Update on the San Francisco-Oakland Bay Bridge East Span California Transportation Commission Meeting

October 21, 2015

Dan McElhinney, Caltrans

THE SAN FRANCISCO-OAKLAND
BAY BRIDGE
SEISMIC SAFETY PROJECT

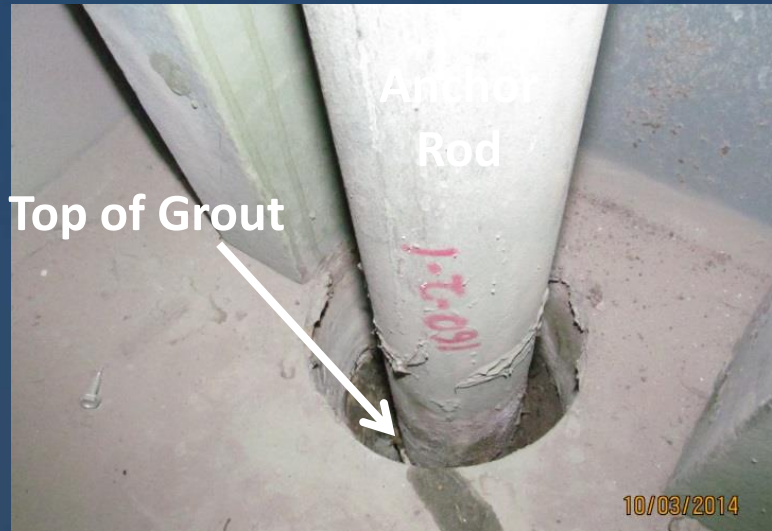
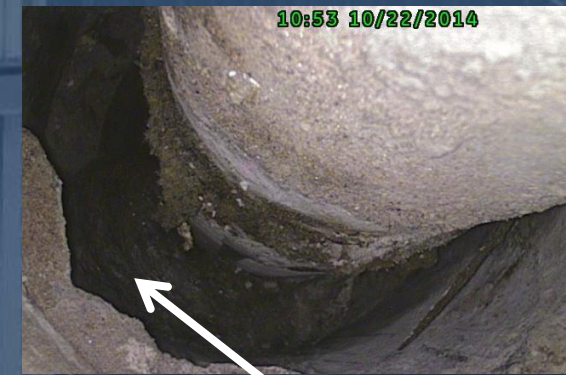
Anchor Rods at Air Bladder Bulkheads

Approx. 150 mm layer of Grout

Anchor Rod Grout Inspection Hole – Operation Visual Inspection (Borescope)

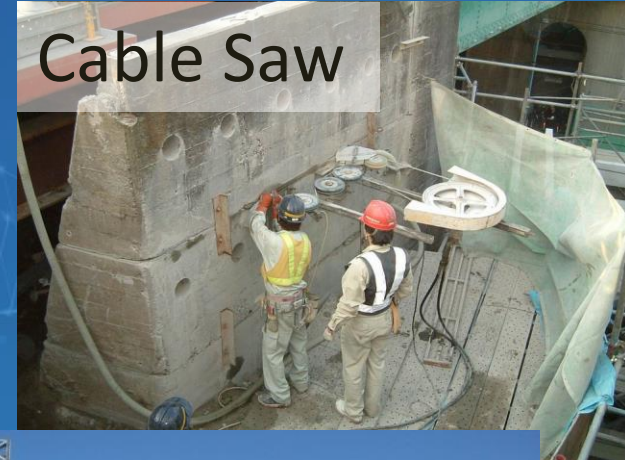
Cable Saw

Cofferdam	Estimated # Piles
54" Pipe Piles	36
24" Pipe Piles	18
King Piles (H-Piles)	170
Sheet Piles	170
Total	394

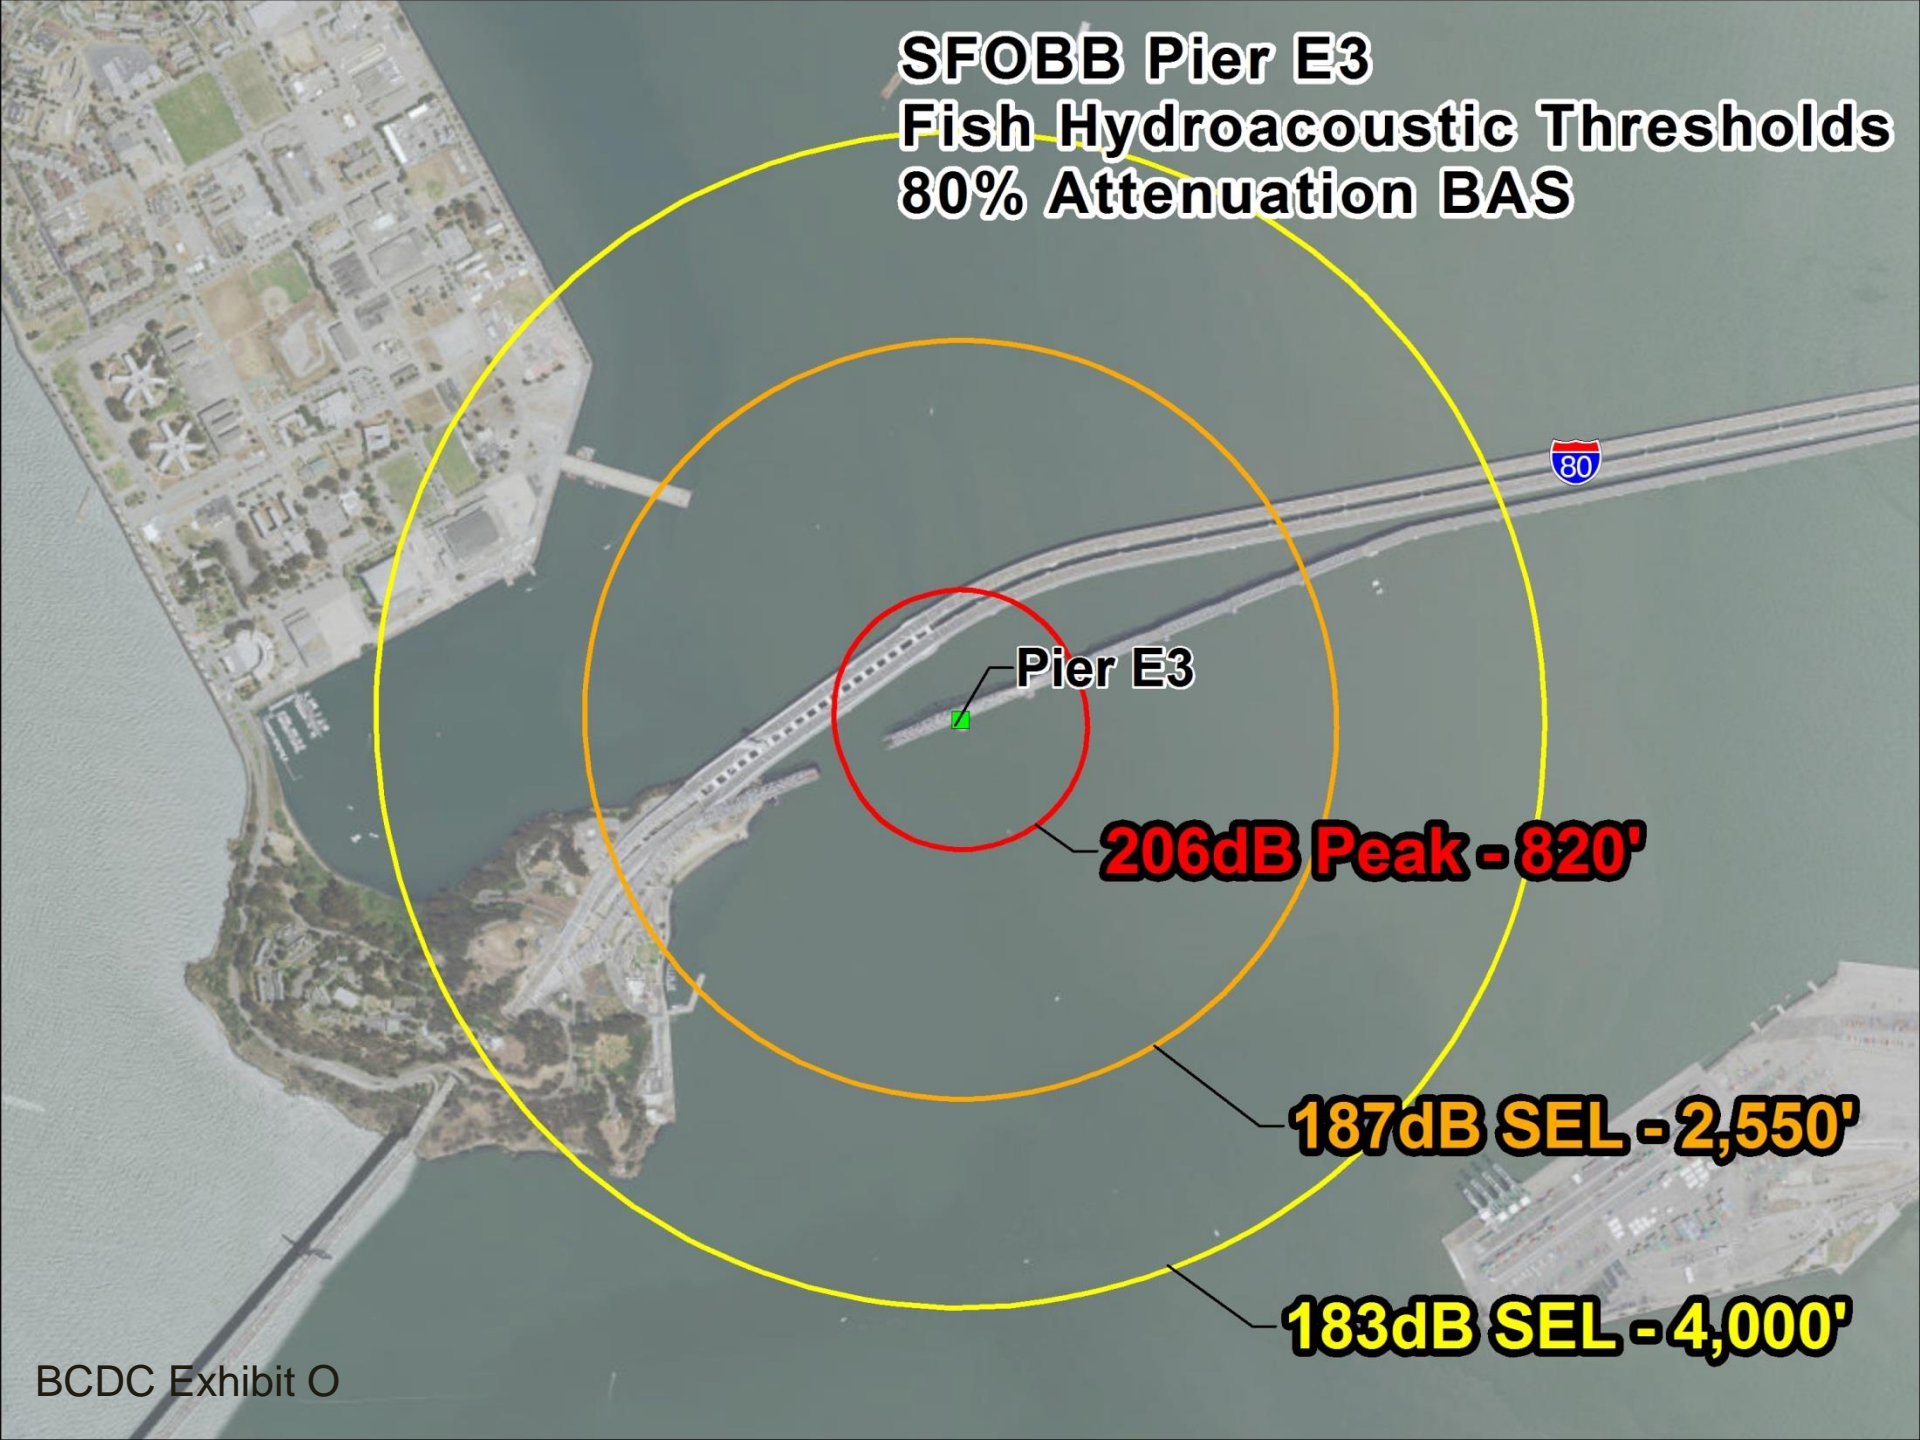
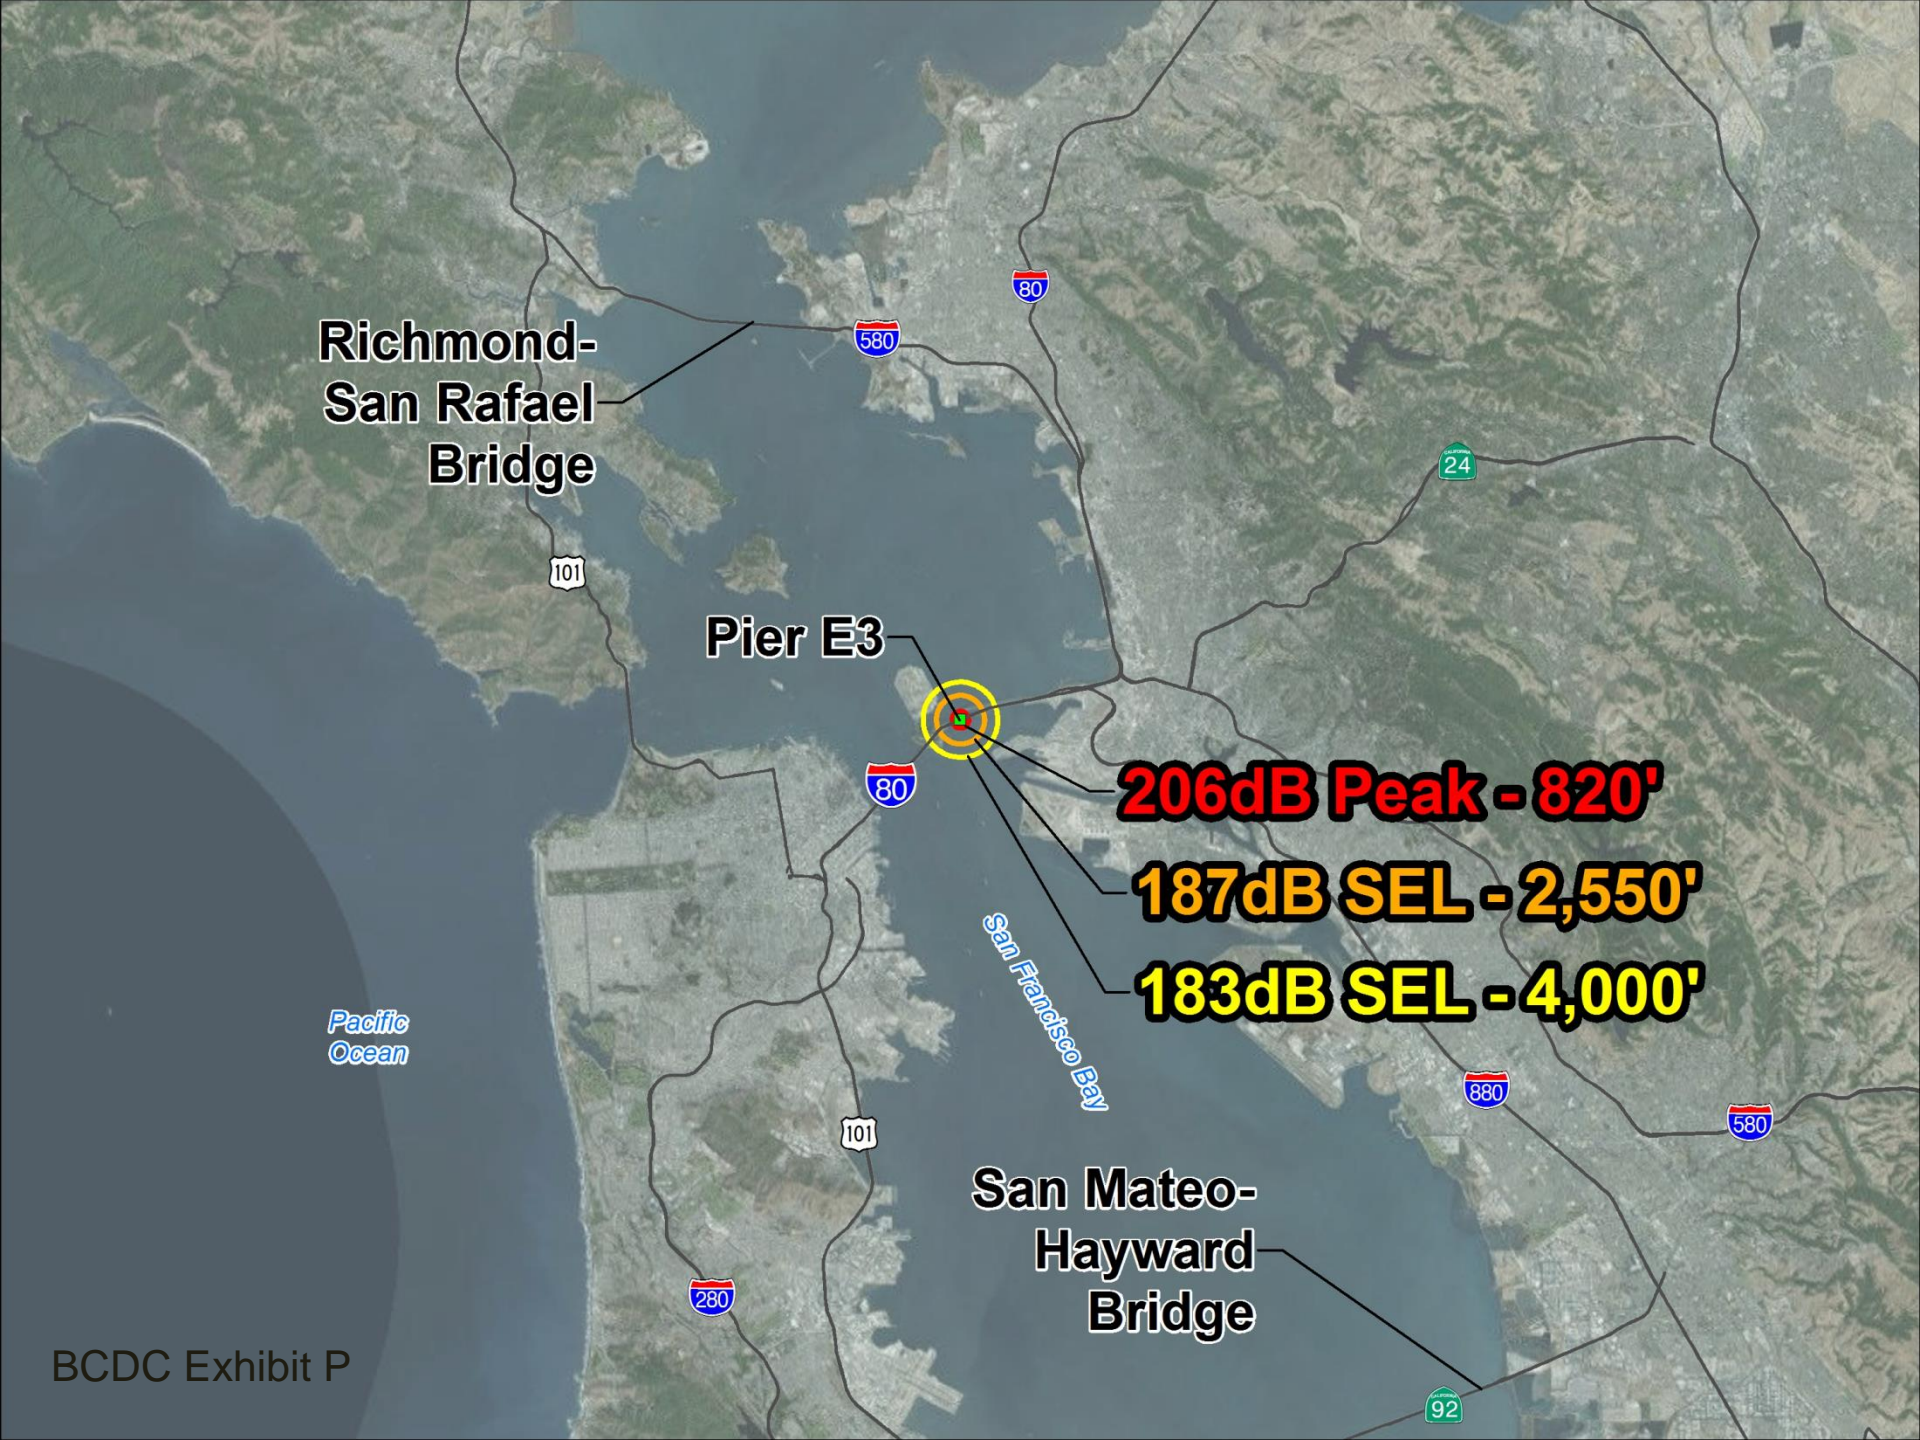
SFOBB Pier E3
Fish Hydroacoustic Thresholds
80% Attenuation BAS

206dB Peak - 820'

187dB SEL - 2,550'

183dB SEL - 4,000'
